Entergy Louisiana, LLC (ELL), requested Quanta Technology, as an independent third party, to conduct this assessment of the transmission system in the Lake Charles area during Hurricane Laura. The transmission system experienced unprecedented wind pressure as a result of the storm, and this assessment evaluates the impact that this wind pressure had on structure failures in the Lake Charles area.

ASSESSMENT OF LAKE CHARLES TRANSMISSION SYSTEM  
 PERFORMANCE DURING HURRICANE LAURA | ELL

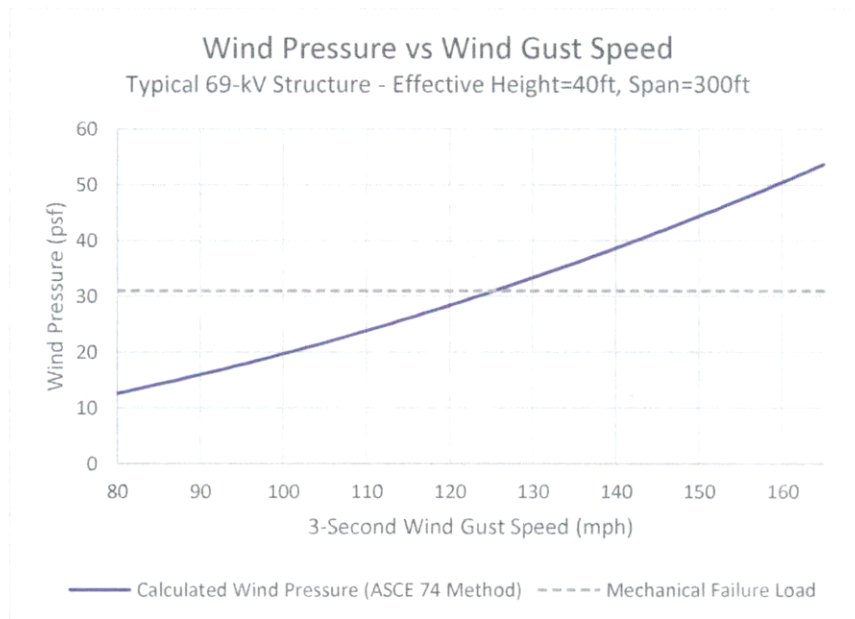
Figure E-1. Wind Pressure Analysis for a typical 69-kV Structure

Figure E-1 below shows the wind pressure analysis for a typical 69-kV structure.

This analysis was performed for each voltage class that had structure failures: 69 kV, 138 kV, 230 kV, and 500 kV. The results of the analysis are summarized in Table E-1 below.

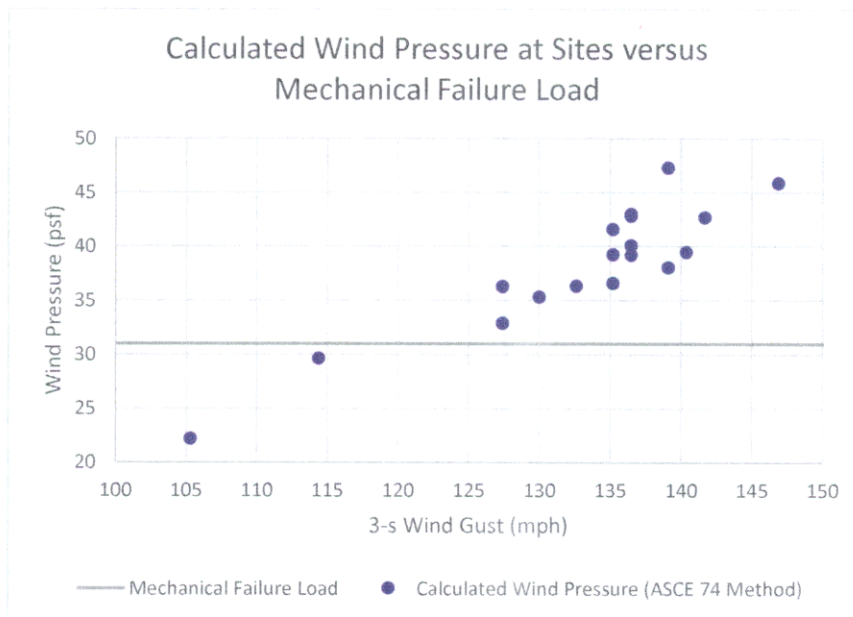
Figure E-2. Line Section Wind Pressures

The analysis of wind pressures concludes that Hurricane Laura exerted wind pressures that exceeded the mechanical failure load of most of the line sections. The line sections that did not experience wind

pressures above the mechanical failure load still experienced loads that were within 5% of the mechanical failure load. The analysis does not take into account the presence of debris or other objects that were present in the wind, the additional load of other, neighboring failed structures, the impact of soil saturation, nor the additional load on the structures that could be present from distribution underbuild and/or third-party attachments that could have been added to the structures after initial construction.

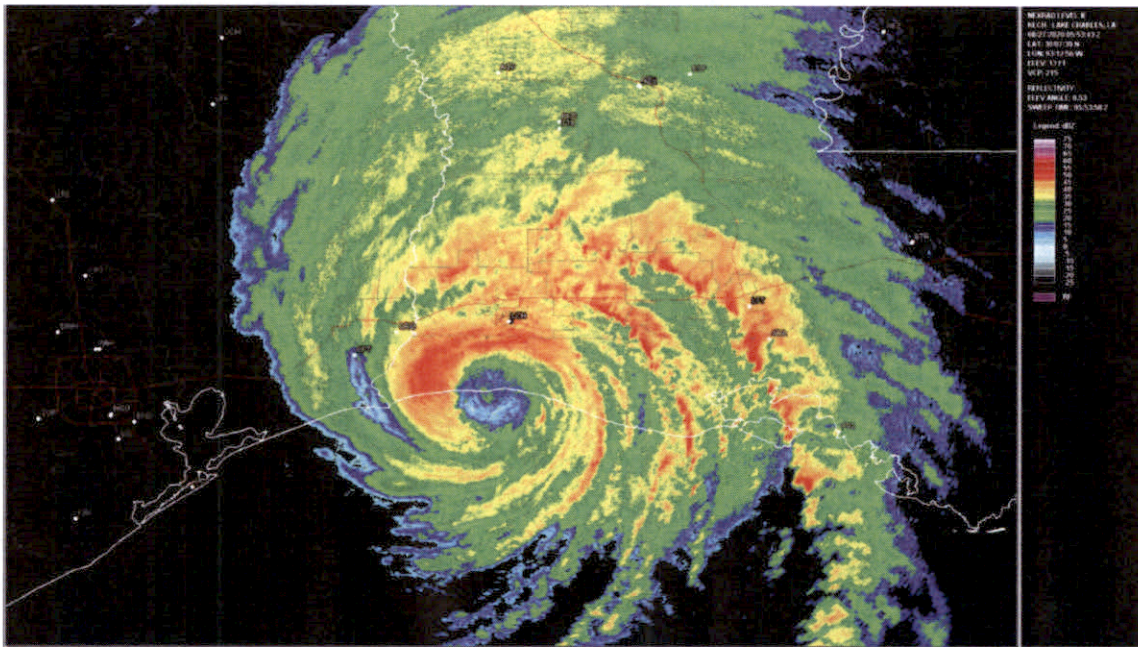
Figure 4-1. Final Radar Image Taken at Lake Charles, LA, WSR-88D Aug 27 at 12:53 AM CDT

According to the National Oceanic and Atmospheric Administration (NOAA) [4], “the National Weather Service in Lake Charles, Louisiana, recorded a station record highest peak wind gust of 116 knots (133 mph) at 1:42 AM CDT before the ASOS (Automated Surface Observing System) wind equipment failed.” The final radar image recorded at Lake Charles, Louisiana, is shown in Figure 4-1.

According to the Weather Channel [5], the radar that failed in Lake Charles sits atop a 20-meter tower. It is very likely the wind speeds were higher at the radome, which is built to withstand Category 4 winds of 140 mph.

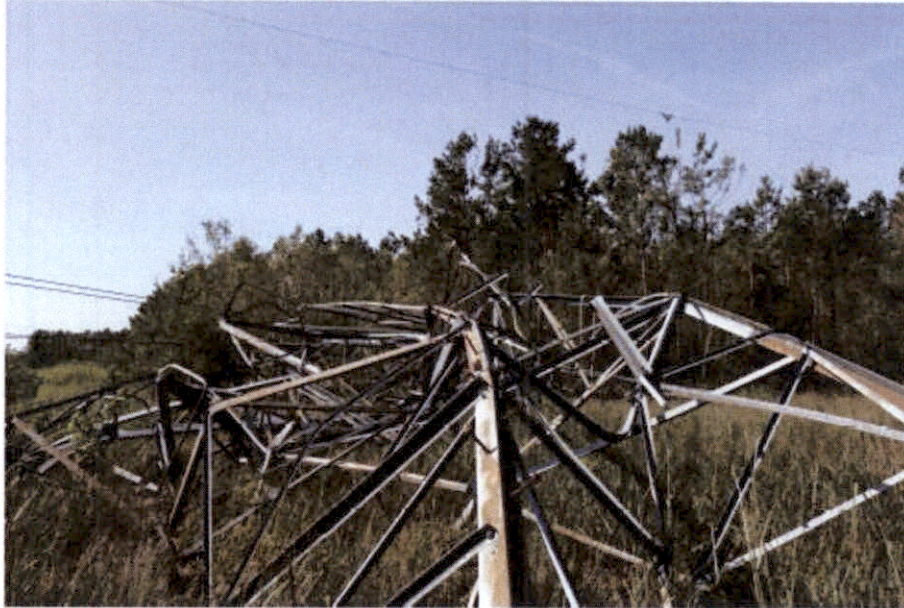
Figure 4-2. Failed Tower Remnants

The following images show examples of the different types of damage to ELL's infrastructure that was witnessed. Figure 4-2 shows a steel lattice tower that failed at the groundline. The steel exhibited superficial rust but was in good shape overall. Figure 4-3 shows a detail of bent stub angles at the foundation of the structure. Steel structures also failed above the groundline, which is indicative of wind-caused damage. Figure 4-4 shows a steel pole that bent above the groundline, and Figure 4-5 shows a steel pole bent right at the groundline. Figure 4-6 shows a steel lattice structure that bent in half at the waist, and Figure 4-7 shows a steel lattice structure that was damaged at the top of the structure.

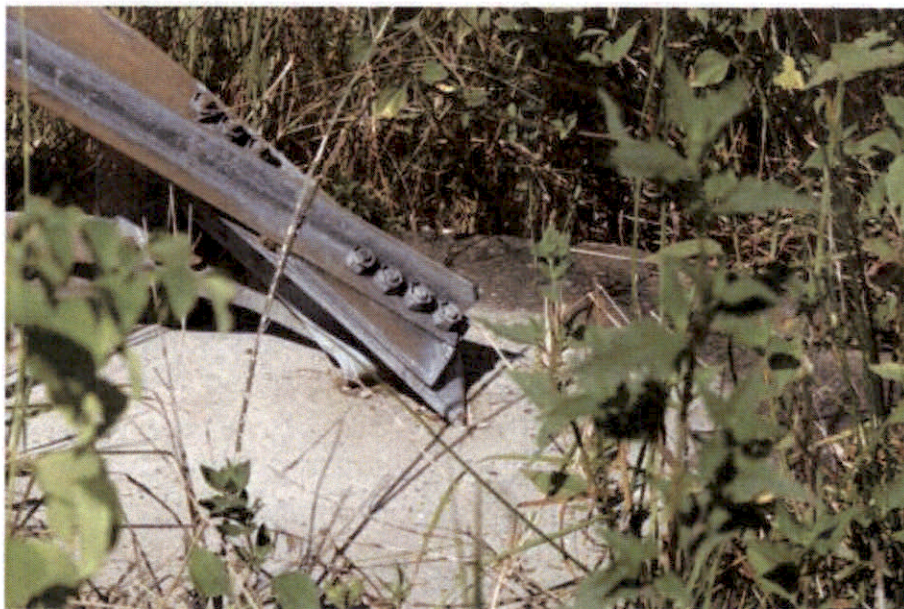
Figure 4-3. Close-up of Stub Angles Bent Over at Foundation on Structures

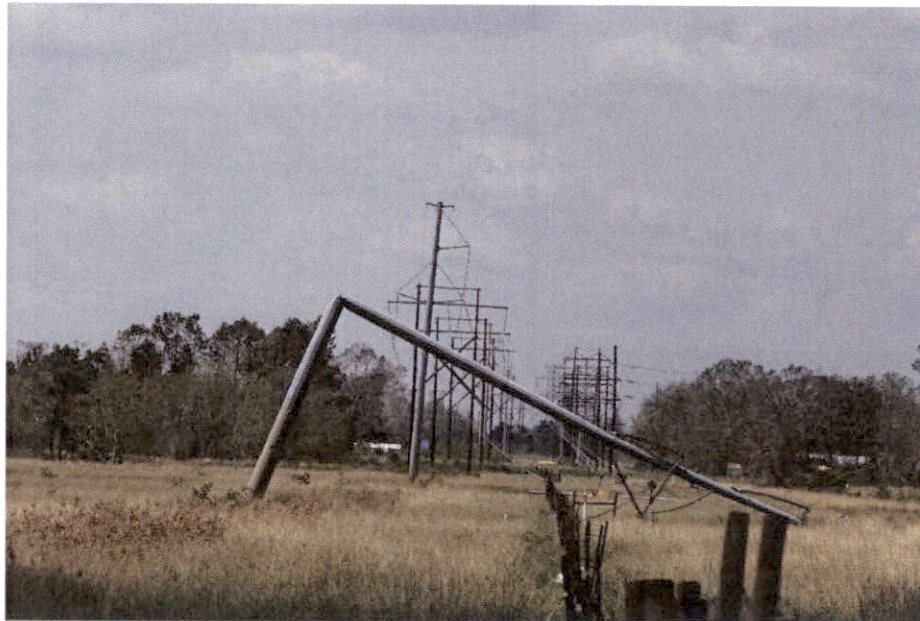
Figure 4-4. Steel Structure Failed above the Groundline

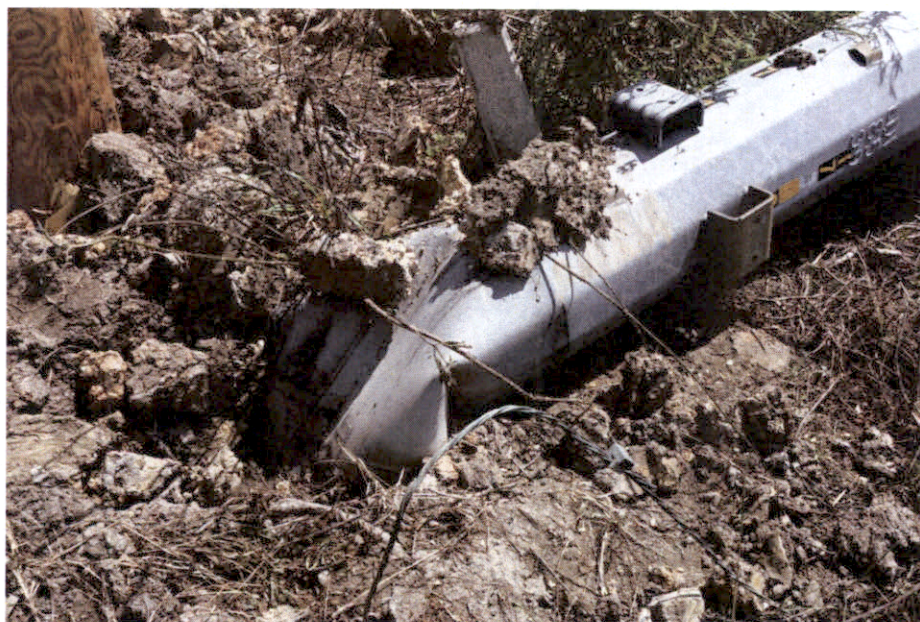
Figure 4-5. Steel Pole Bent at the Groundline

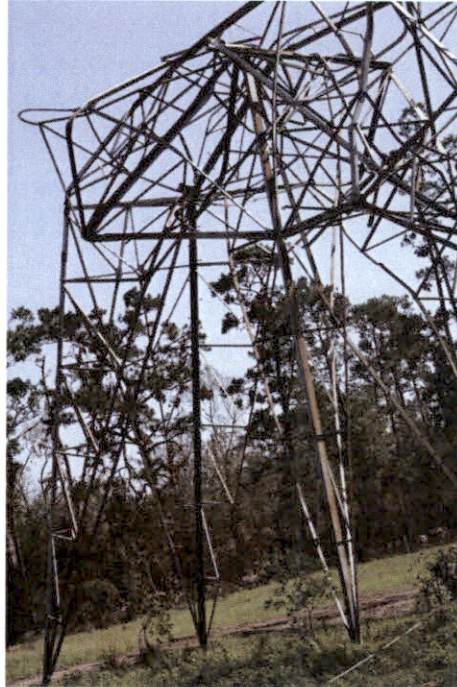
Figure 4-6. Steel Structure Failed at the Waist

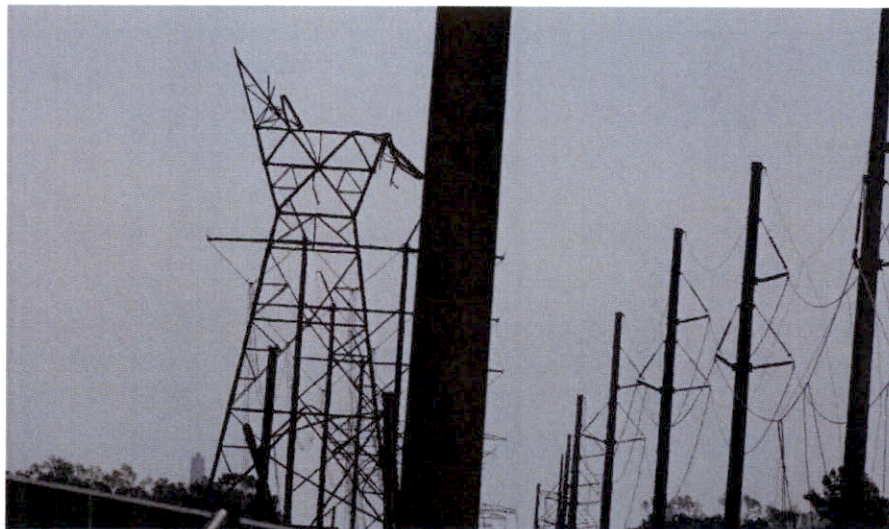
Figure 4-7. Steel Structure Damaged at the Top of the Structure

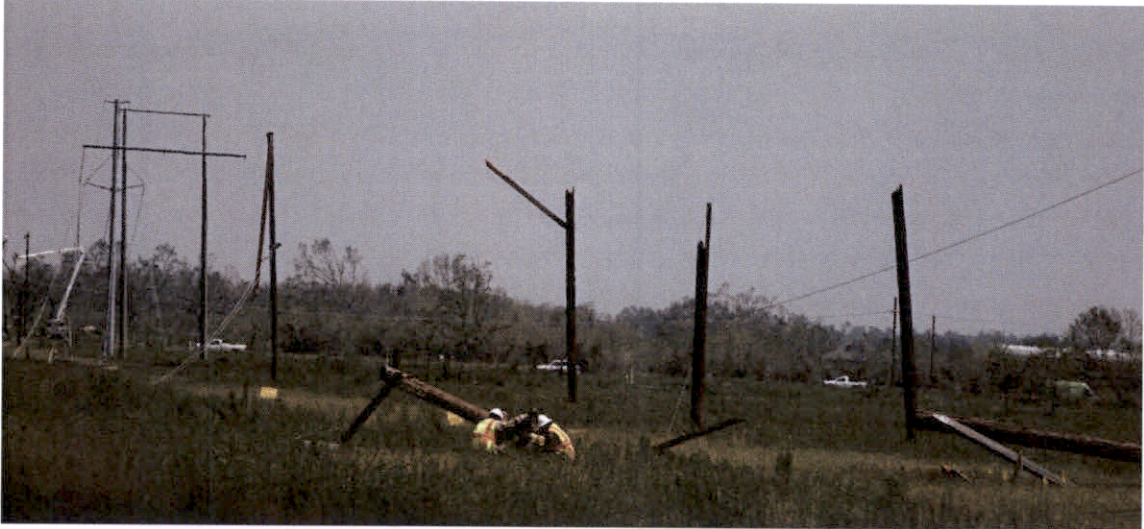
Figure 4-8 shows several wood poles that broke well above the groundline. This type of damage is typical of wind-caused failures.

Figure 4-8. Wood Poles Destroyed above the Groundline

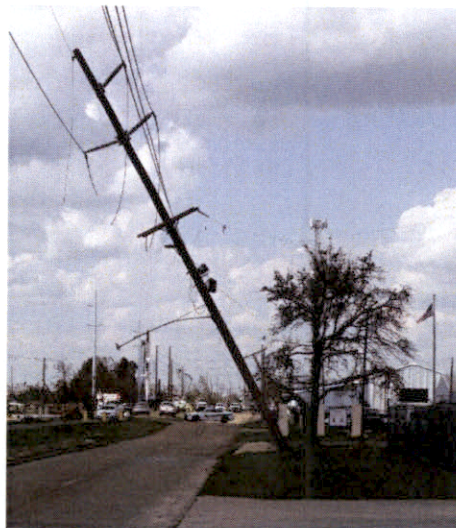
Figure 4-9 and Figure 4-10 show a wood pole leaning due to soil displacement.

Figure 4-9. Wood Pole Leaning Due to Soil Displacement

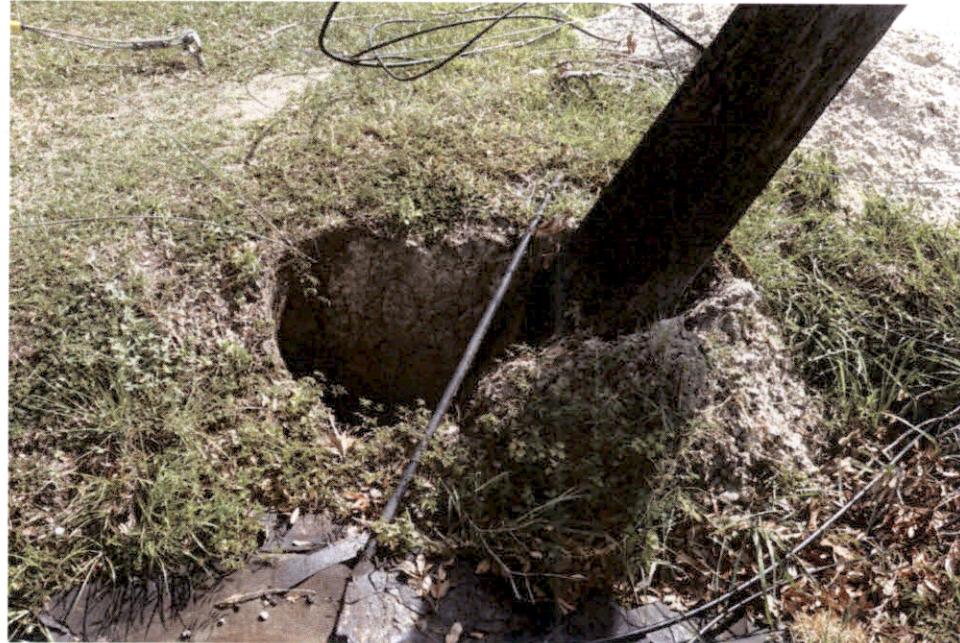
Figure 4-10. Displaced Soil at Base of Pole

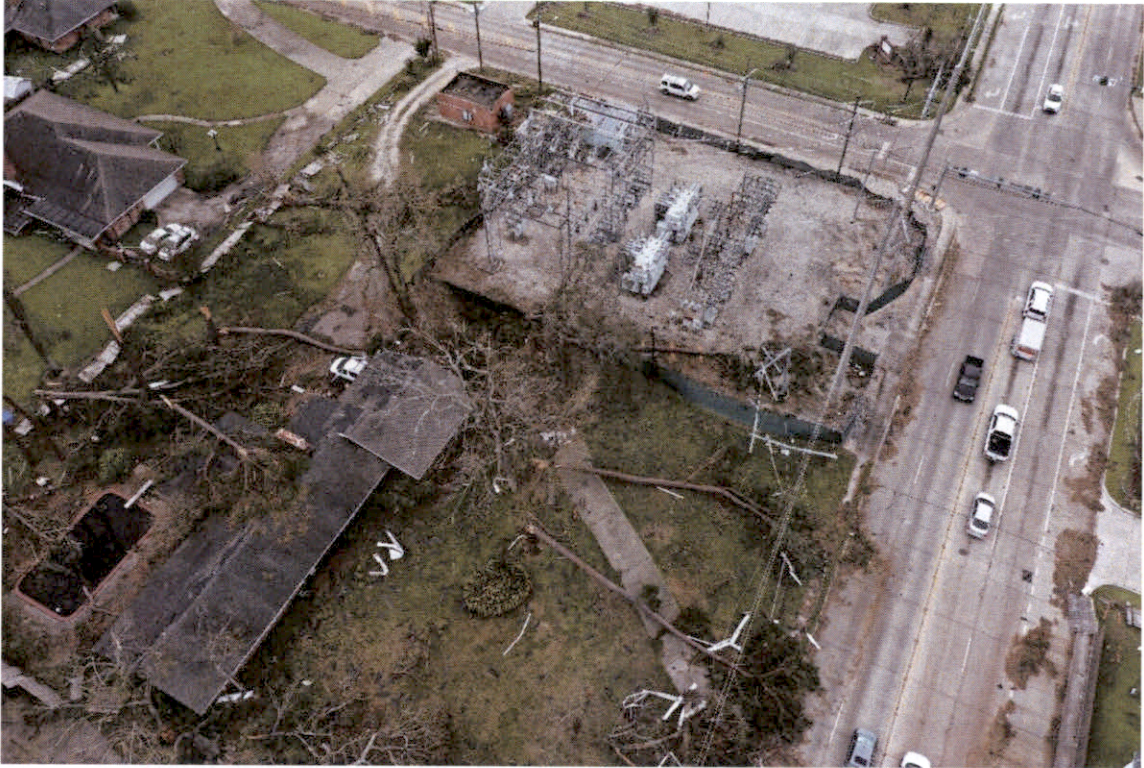
The winds caused extensive damage, destroying trees near the transmission structures. Vegetation from well outside of the transmission ROWs was blown into lines. Figure 4-11 shows trees that were knocked over by the wind in the vicinity of the transmission lines near Lake Street in Lake Charles.

Figure 4-11. Trees Damaged near Transmission Line
