9 **V. RESTORATION OF THE TRANSMISSION SYSTEM**  
10 **FOLLOWING THE HURRICANES**

11 **A. Description of Restoration Efforts**

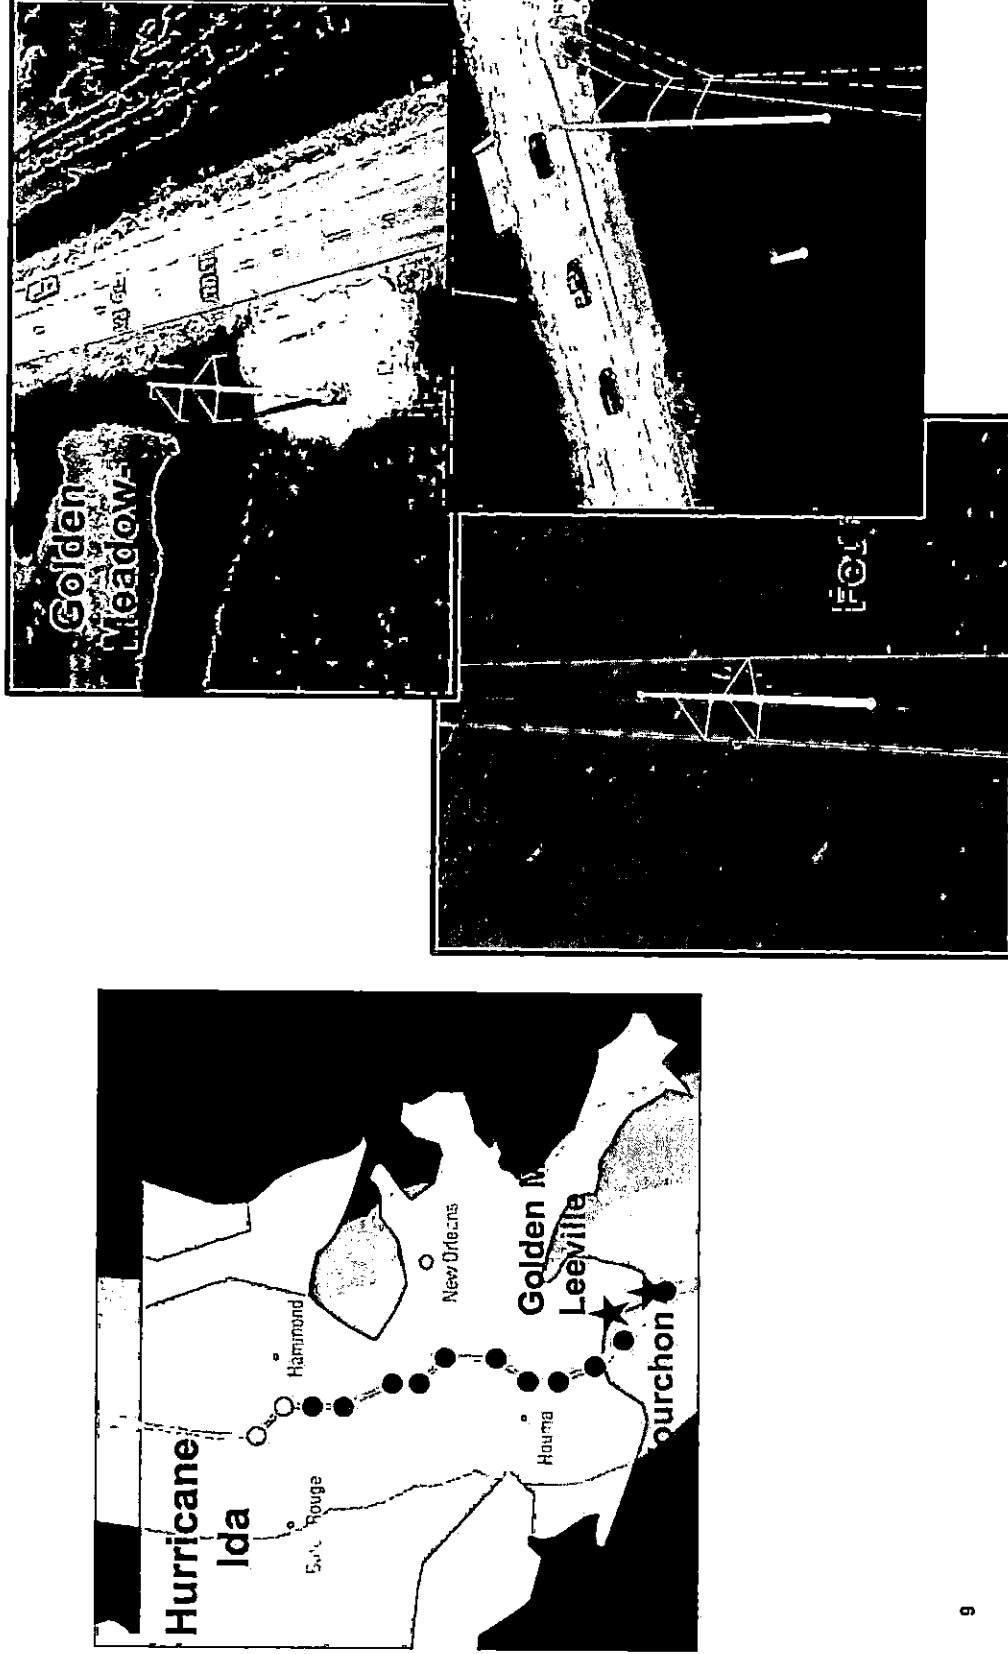
# More Recently Installed Transmission Facilities Performed Well During Hurricane Ida
