**BEFORE THE
LOUISIANA PUBLIC SERVICE COMMISSION**

***IN RE:* APPLICATION OF ENTERGY)
LOUISIANA, LLC FOR RECOVERY)
IN RATES OF COSTS RELATED TO)
HURRICANES LAURA, DELTA,)
ZETA, AND WINTER STORM URI)
AND FOR RELATED RELIEF)**

DIRECT TESTIMONY

MICHELLE P. BOURG

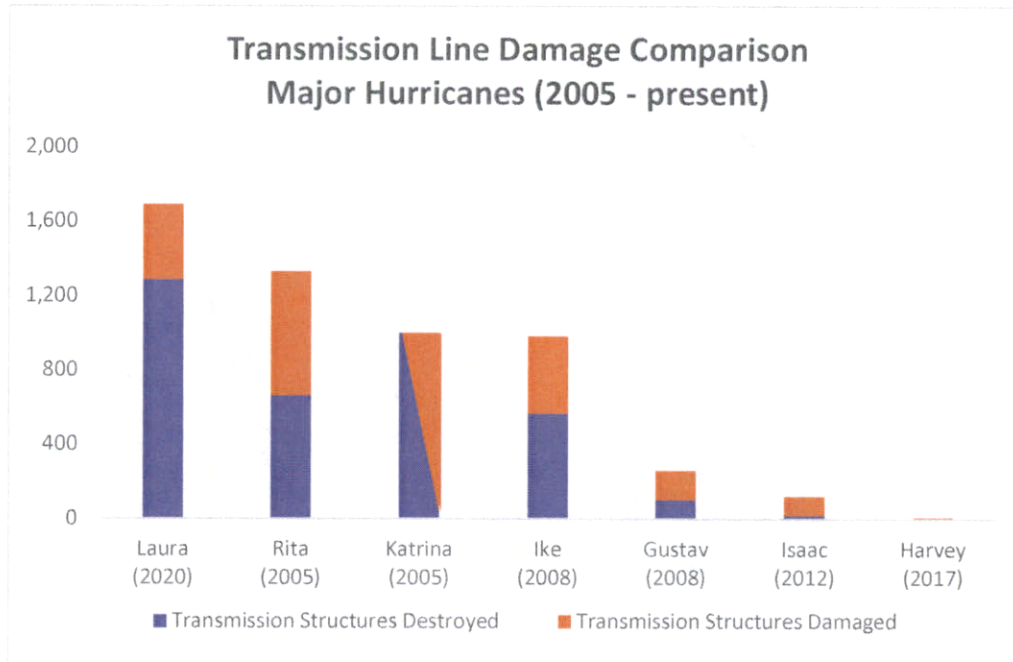
Figure 1⁶

10 A. The nature and magnitude of the damage inflicted to the transmission system in southwest
11 Louisiana were very different from the experiences with past hurricanes that impacted
12 ELL's service area. In fact, the damage as so severe that it was more consistent with
13 destruction caused by a tornado, but across a much wider path. Figure 1 below compares
14 the damage inflicted to the transmission system by Hurricane Laura to other major
15 hurricanes that have impacted Louisiana since 2005.

⁶ Transmission structure damage information for Hurricane Katrina displayed in Figure 1 reflects total structures impacted (i.e. – sum of damaged and destroyed structures).
